ADDRESS: Former Esser Paint Facility - 3131 W. Galena Street, Milwaukee, WI

Sigma Project Number: 11525

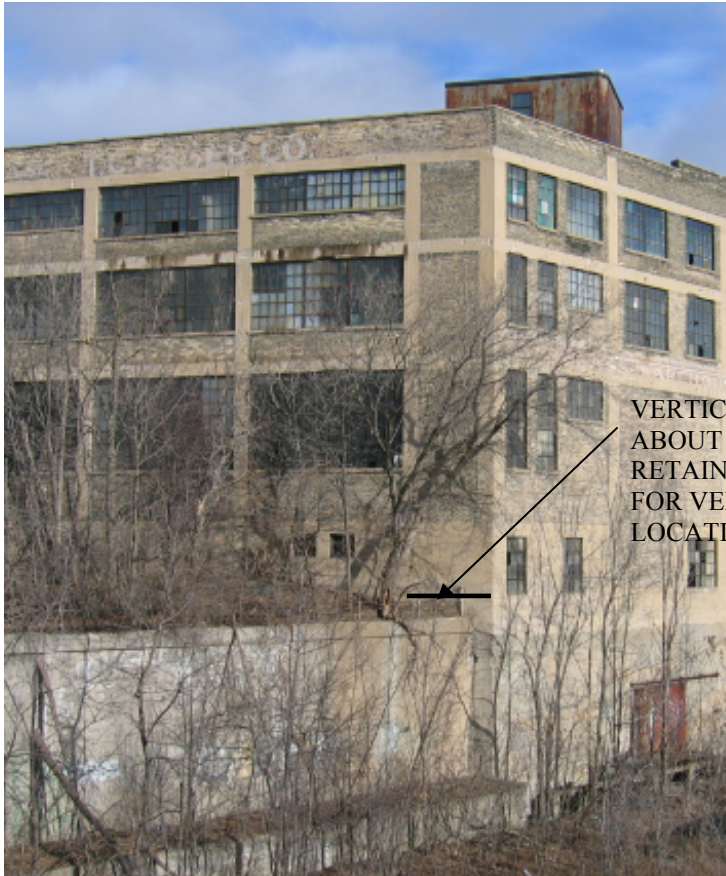
**PHOTO 5: 1931 BUILDING
SOUTH END**

VERTICAL DEMO LIMIT- EXTENDS TO ABOUT 5 FEET WEST OF RAILROAD RETAINING WALL. REFER TO SPECS FOR VERTICAL LIMITS WEST OF THIS LOCATION.

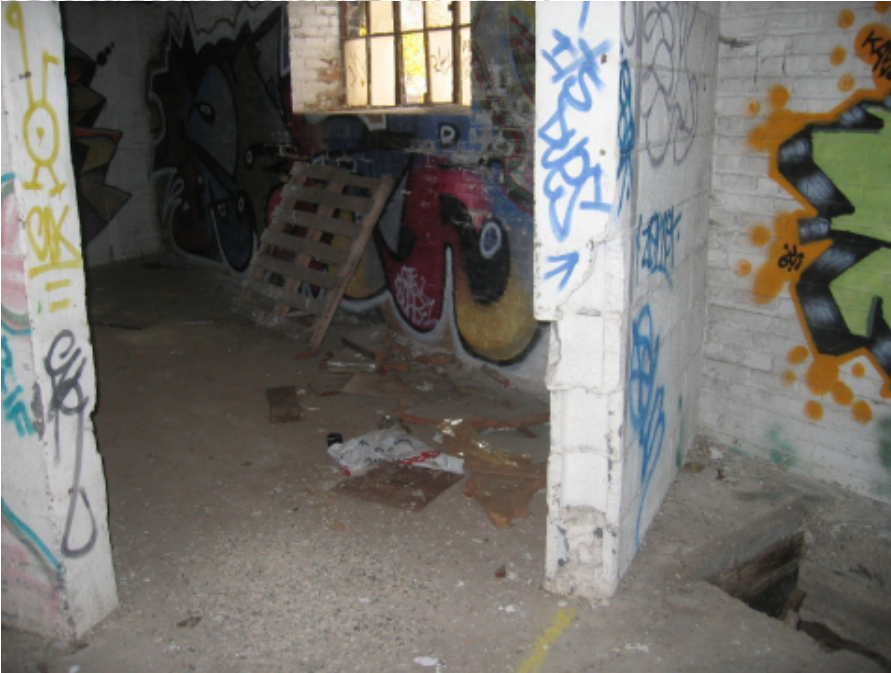
PHOTO 6: Slab on grade and trench inside 1931A building .

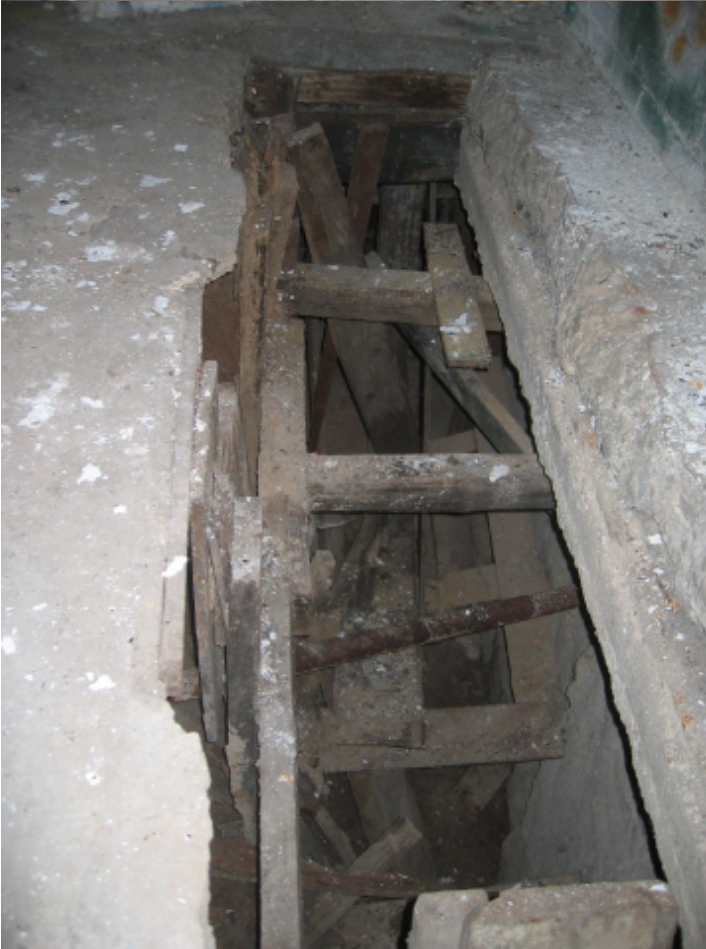
PHOTO 7: Trench along retaining wall inside 1931A building with tiebacks and bracing. Protect tiebacks during trench repair. Recently this area sustained cave-ins of the concrete slab on grade. Remove all concrete debris before trench is filled per detail D/S4.

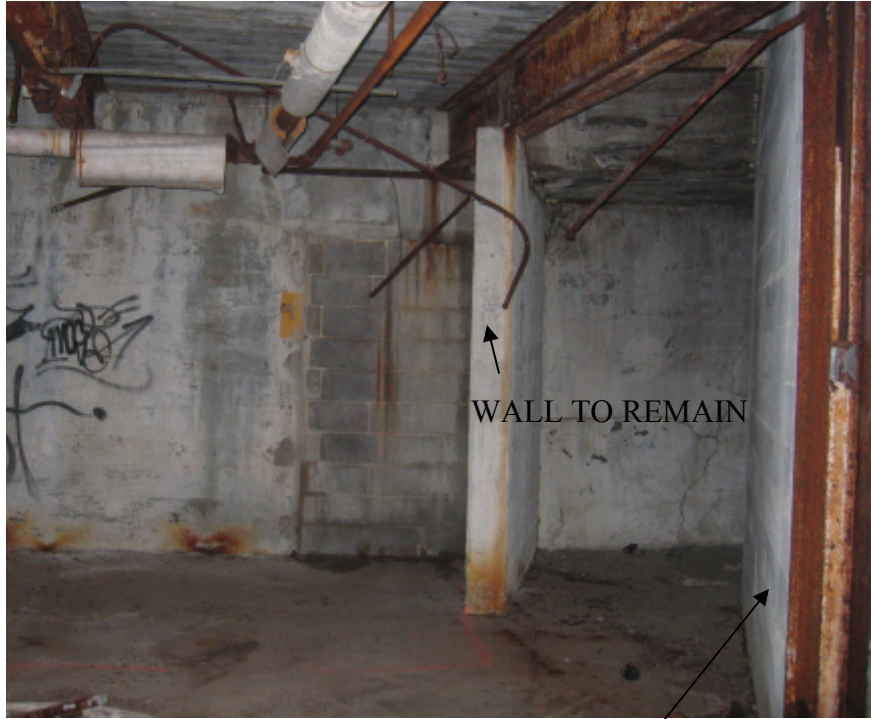
PHOTO 8: Wall perpendicular to north wall by stair to remain. Top of wall to slope to proposed grade.
